# Squire SS-100 Registry Newsletter

Winter 2009

## **Mascot Madness**

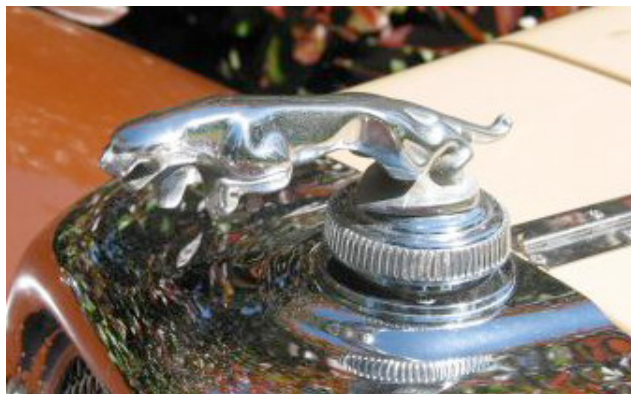
Leaping jaguar with knurled cap on a kit car

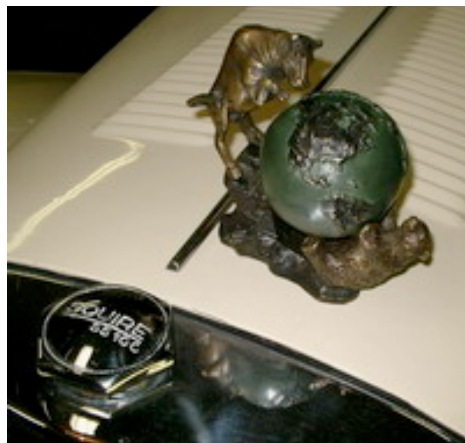
**Bull and Bear with stock hexagonal cap.**

Back on the computer I began the search for a bull of suitable size and pose. Eventually I found a company that sells executive desk ornaments. They had a stock market themed bronze statue of a bull and a bear fighting over the world. The bear was on his back supporting the world on his paws and the bull was "rampant" with his front hooves up on the world. There was an irregular "rocky" base as part of the statue but the world was removable. The bull was about the right height. I ordered one of these statues and in due course it arrived.

It was a very heavy thing! I lifted out the world and became the owner of a surplus somewhat irregular cannonball. I was pleased to note that the bull's front hooves were lifelike and not shaped in some concave way to fit the world. I determined a suitable location and angle, such that the front edge of the hood would clear the bull's tail when opening and closing, and cut through the rocky base to separate the bull. I found that it was a thin walled brass casting filled with solder and the bronze finish was an externally applied patina. The bull was joined at his rear

hooves to the rocky base and he was no doubt also filled with solder. I pushed the base back and forth on a piece of sandpaper until I had a nice flat surface. I wondered if the solder would be strong enough to drill and tap for coarse threaded mounting bolts so I sliced the bear in half (same construction) and made a test hole in his sectioned abdomen. It seemed strong enough although certainly not as good as if the statue had been solid brass.

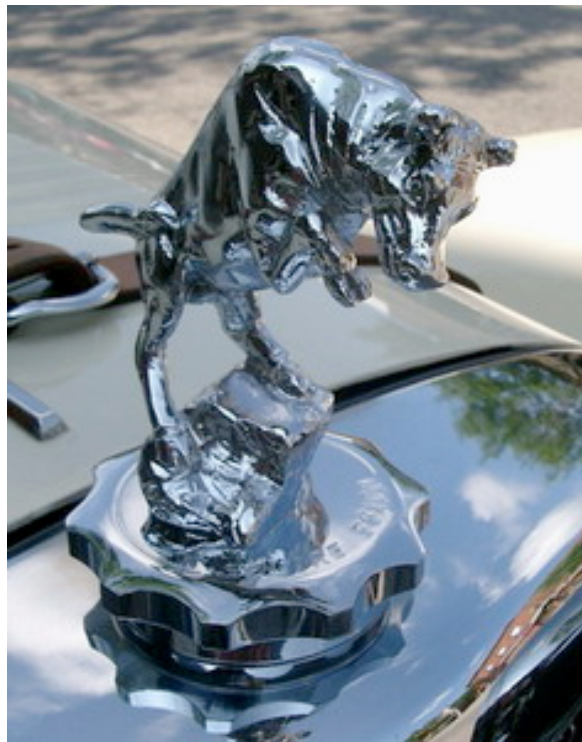
**New rampant bull mascot and scalloped cap.**

While all this grief was being endured I also designed a new flat-topped radiator cap on which the bull would stand. I went with a scalloped circumference rather than the hexagonal shape of the original cap. I designed the engraving of "Squire SS100" and a sort of beauty groove on the top. The machinist and I e-mailed drawing files back and forth until we had something I liked which he could do on his computer controlled milling machine. He made it out of solid brass and charged me a lot less per hour than I had paid the bicycle welder for his less than wonderful results.

Since the bull base was now hollow and I didn't trust the welder to join the base to the cap neatly I had to think of another way to join them. I made a brass plate which just fit inside the base if I forced it in and then drilled and tapped two holes in it as far apart as I could get them. Then I got the plate welded to the base (no problem with that). I didn't drill mating holes in the cap because if the bull plating was a disaster I would still have a nice looking new cap.

In due course (seven months after starting the project) I assembled the bull to the cap and was tempted to put it on the living room mantle. This idea met with some resistance so I put it on the car. You may or may not like it but you'd have to be rather insensitive to be indifferent. Oh, in case you were wondering, I might be able to look up where I bought the original statue and I can send you a copy of the cap drawing but I emphatically refuse to make another one for anybody.
